ADDRESSING FAILURE MODES TO BUILD A BETTER HOSE

**Peerless forensically analyzes hose failures
to re-engineer a more efficient & effective solution.**

APPENDIX C - Hose Master Failure Analysis Report

Failure Analysis Report – RMA No. 8481

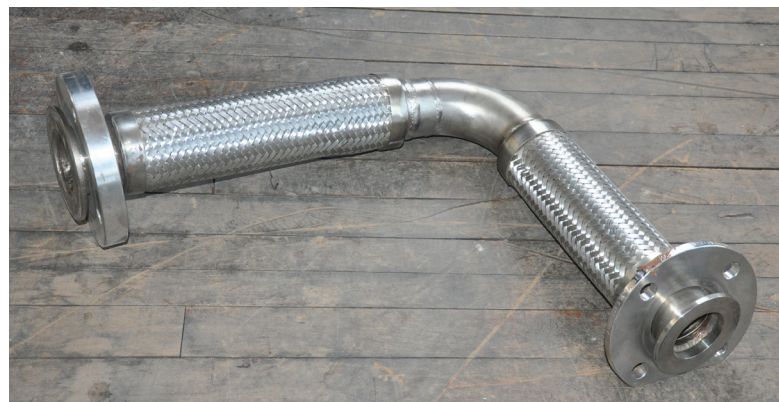
Completed Dogleg Assembly - Design 1 for Customer's Initial Requirement

8/13/2013 Hose Master recommended furnishing a hose assembly with double braid, heavier wall thickness and a liner installed internally that would smooth the flow. At high velocities this smoother flow results in less vibration.

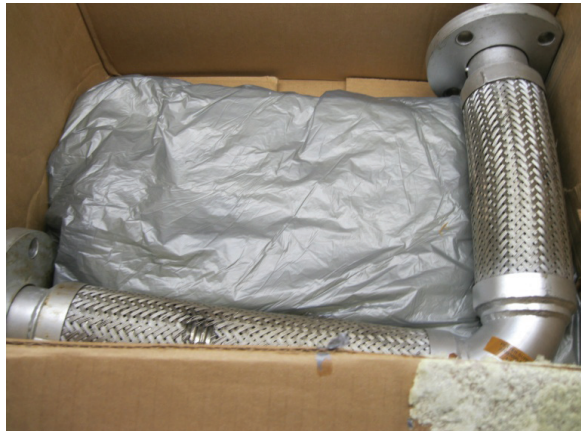
The as-received assembly was in fair condition. (See photograph 1)

Photo 1 – As-received assembly.

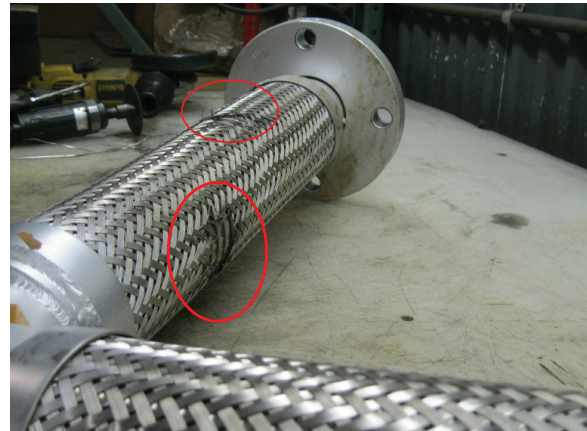
Braid damage in several locations was found on both sections of the assembly. Indications of wear originating from the exterior were present. This included several sections of braid missing from the affected areas as well as heavy braid wear on the corrugation crests. (See photographs 2 - 4)

Photo 2 – Examples of braid damage on the assembly.

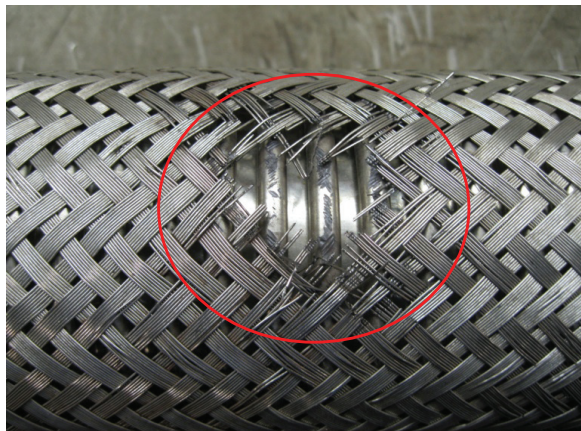
Photo 3 – Example of missing braid.

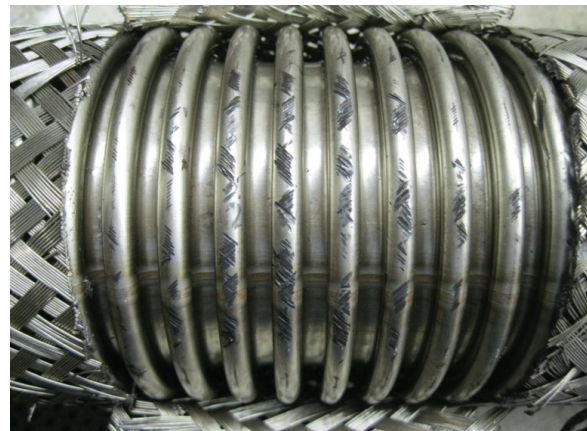
The assembly was then tested with 40 PSI of nitrogen while underwater. Leaks originating from several corrugation crests within the damaged sections of braid were found. A representative section was removed for microscopic examination.

Photo 4 –Braid wear present on corrugation crests.

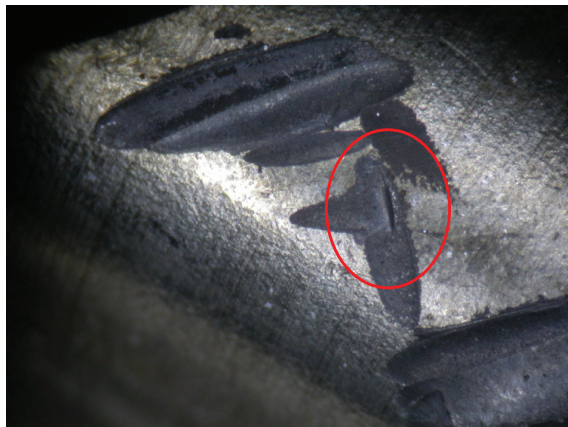
Under magnification, fractures were found within the braid wear on the corrugation crests. (See photographs 5 & 6)

Conclusion:	Code:W02 - CL
<p>The assembly failed due to wear originating from the exterior of the assembly.</p>

Photo 5 – Fracture within braid wear. 20x

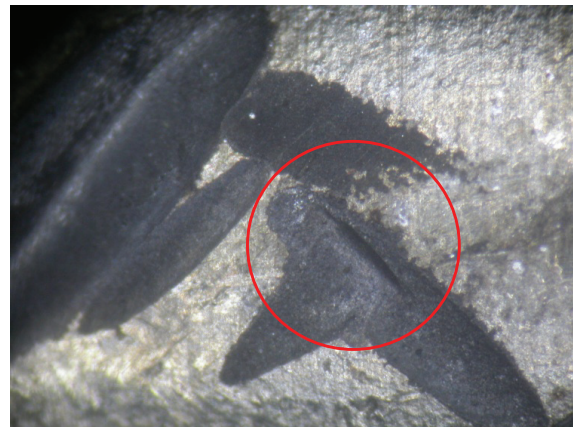
Photo 6 – Fracture within braid wear. 40x
