ADDRESSING FAILURE MODES TO BUILD A BETTER HOSE

**Peerless forensically analyzes hose failures
to re-engineer a more efficient & effective solution.**

APPENDIX C - Hose Master Failure Analysis Report

Failure Analysis Report – RMA No. 8481

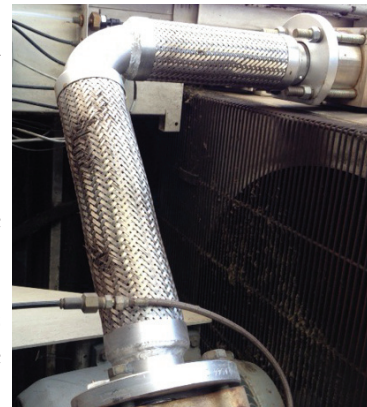
Peerless obtained one of the failed hoses, which was then submitted to Hose Master for rigorous failure analysis. At this time, the hose in question was reported to have failed after a only few months in service.

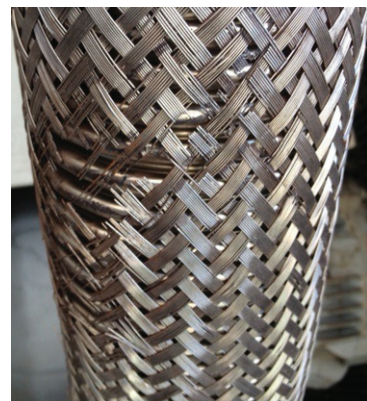
7/29/2013 Hose Master issued RMA 8481(Appendix B) and provided photos in a failure analysis report (Appendix C). These photos show the condition of the hose as received and damage to the corrugated tube upon closer inspection.

The report revealed that the hose assembly failed due to wear originating from the exterior of the assembly. In addition, it was noted that this assembly was subject to extremely high velocities and subsequent vibration.
